**Flood Control Project Maintenance
Levee Inspections**

Fall 2018 Levee Maintenance Deficiency Summary Report

Sacramento River Basin

**Flood Control Project Maintenance
Levee Inspections****LMA District Cover Sheet
Fall 2018 Levee Inspection Results****Reclamation District No. 0349 Sutter Island**

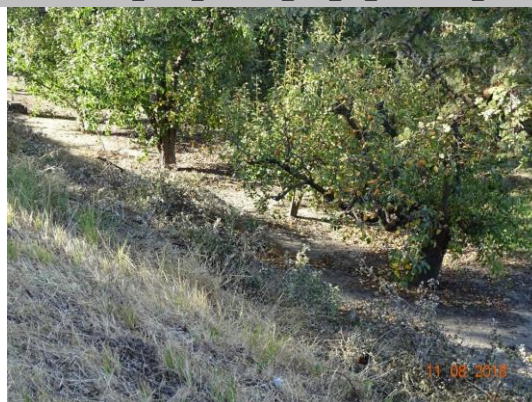
Photo 1 of 1 : FA_2018_RD0349_204_17_20181109_00028.jpg

View of orchard trees encroaching on the land side toe (November 2018).

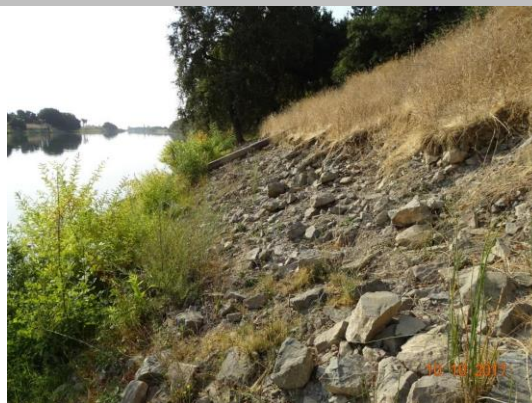
Photo 1 of 1 : FA_2018_RD0349_204_15_20180925_00003.jpg

Comment Code					
Inspector Comment					
Levee Evaluation Comments					
Description:District Station 52+92 to 55+88, Sec. 06, T. 5 N. R. 4 E., M.D.M. Approximately 296 linear-feet of eroded area exists along the waterside levee slope of the Sacramento River (Unit 1). Erosion commences at approximately 3/4 of the way down the slope from the crown and extends into the rip rap. Some rip rap has been pulled off in this section.					
Site ID No:318					
Site Designation:LMA-145					
Repair Type: Erosion					
Rating:Area of Concern					
Field Date:7/28/2017					
Notes: slope too steep, vegetation too thick for clear inspection, no direct visual of damage

Waterside erosion at LM 1.02.

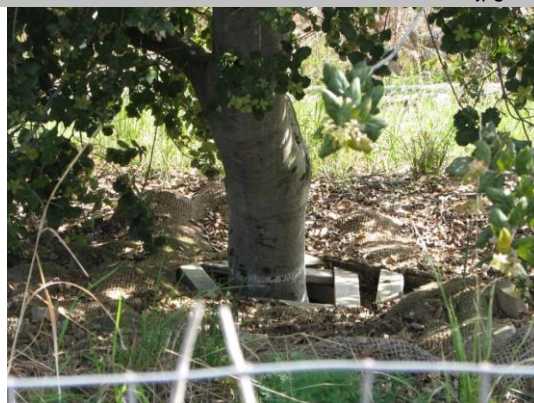
Photo 1 of 3 : UCIP_FA_2018_44304_36580.jpg

Geotech fabric and protective frame at tree--design features of erosion repair site 2007-2009.

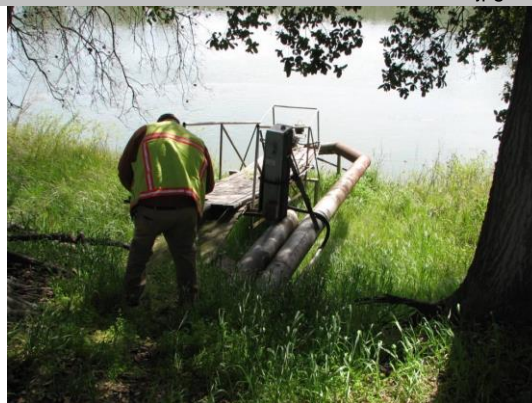
Photo 1 of 3 : UCIP_FA_2018_21576_36593.jpg

Dense vegetation on waterward slope--2 pipes and 1 conduit.

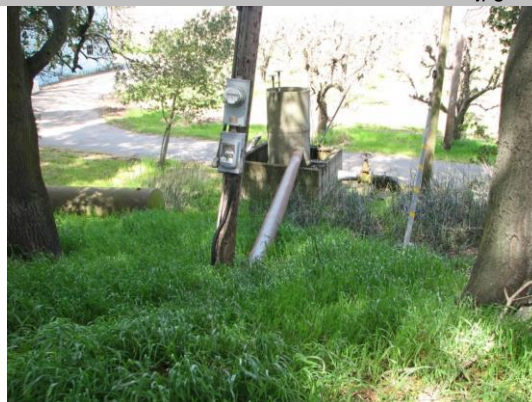
Photo 3 of 3 : UCIP_FA_2018_21576_36591.jpg

Multiple appurtenances found on landward side-standpipe, electrical pole, valve, concrete distribution box.

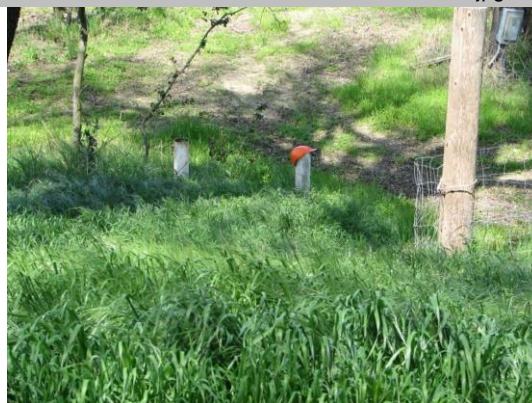
Photo 1 of 3 : UCIP_FA_2018_21614_36691.jpg

View of landward side--unable to inspect.

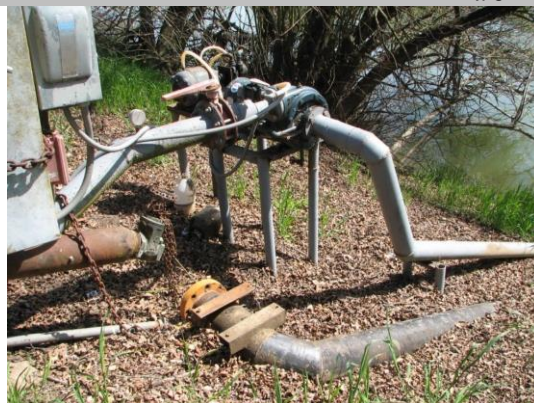
Photo 3 of 3 : UCIP_FA_2018_21614_36689.jpg

New configuration--sections of pipe have been abandoned.

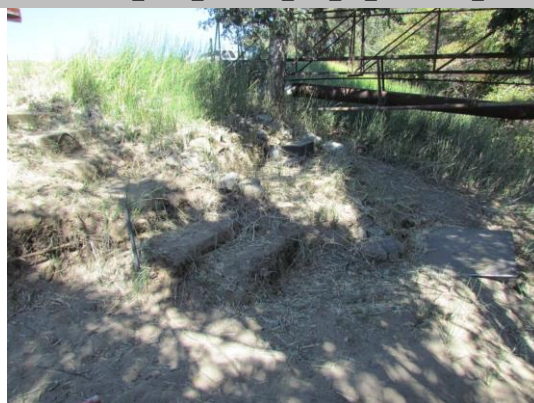
Photo 2 of 2 : FA_2018_RD0349_205_36_20180925_00014.jpg

The landowner has knotted step into the waterside slope.

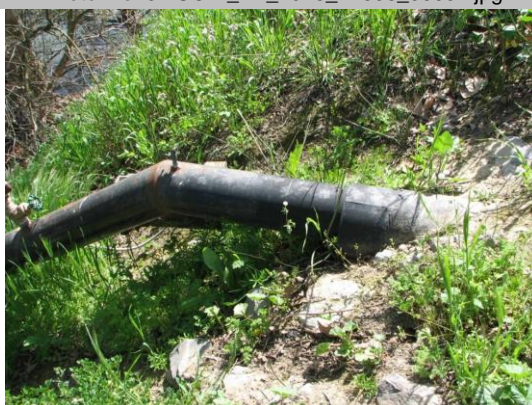
Photo 2 of 3 : UCIP_FA_2018_21606_36654.jpg

Smaller pipe sleeved through larger pipe that goes through levee.

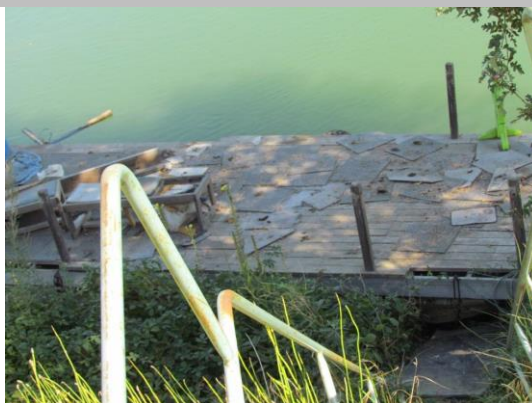
Photo 3 of 3 : FA_2018_RD0349_205_1_20180925_00003.jpg

Unauthorized dock at waterside toe.

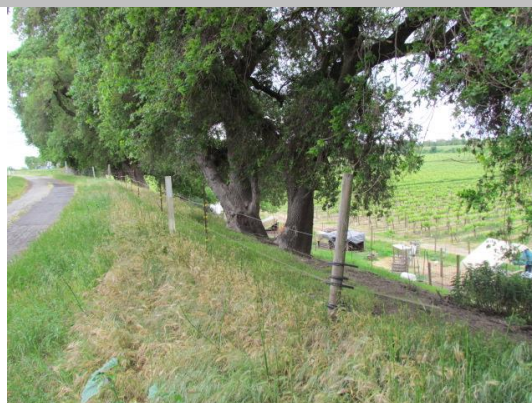
Photo 1 of 1 : FA_2018_RD0349_205_59_20180925_00036.jpg

Unauthorized electric fence installed along the shoulder and levee slope landside .

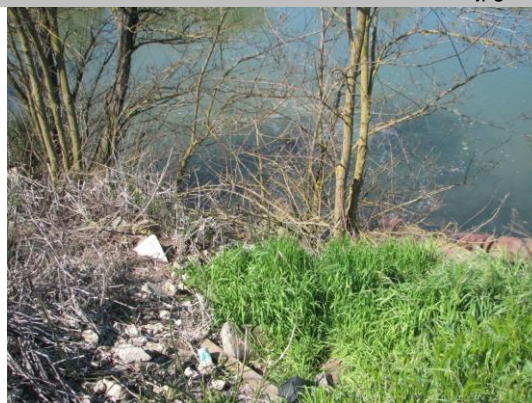
Photo 3 of 3 : UCIP_FA_2018_21632_36734.jpg

All 3 pipes visible on waterward side--tall grass limits inspection on waterward side.

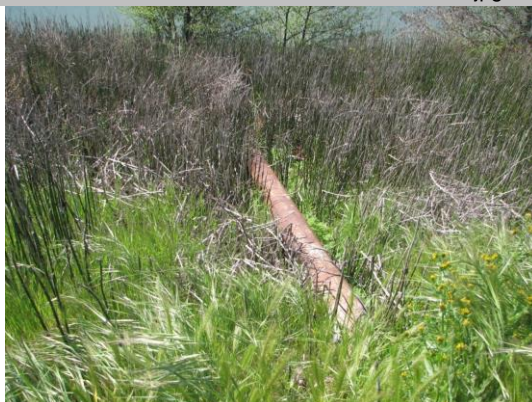
Photo 2 of 2 : UCIP_FA_2018_21634_36738.jpg

View of waterward side--dense vegetation limits inspection.

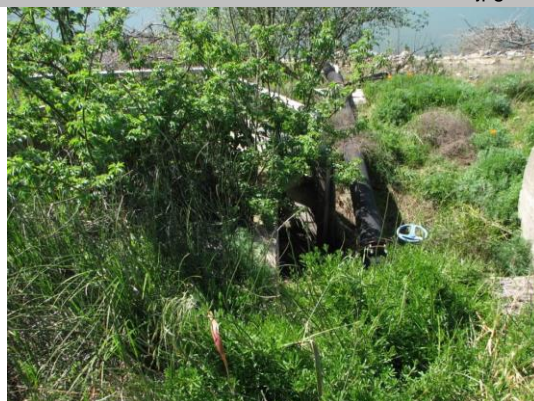
Photo 1 of 3 : UCIP_FA_2018_43424_36869.jpg

Waterward side--appears to be an erosion repair site. New pipe on waterward side and damaged pipe on landward side.

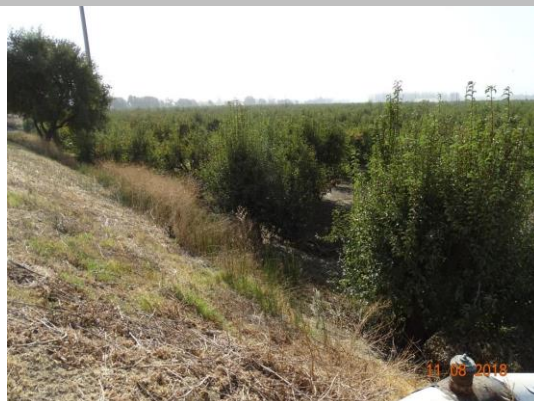
Photo 1 of 1 : FA_2018_RD0349_206_74_20181109_00083.jpg

View looking slightly upstream at orchard trees on the land side toe (November 2018).

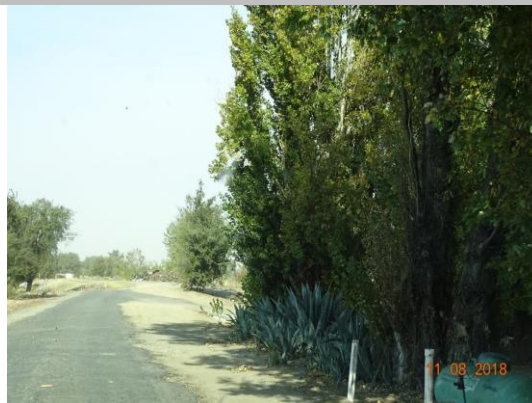
Photo 1 of 1 : FA_2018_RD0349_206_66_20181109_00082.jpg

View looking downstream at land scaping on the water side shoulder (November 2018).
